Manhole Inspection Summary

Manhole # S31YY1019MH

Location Address: **5309 CHARLES ST**

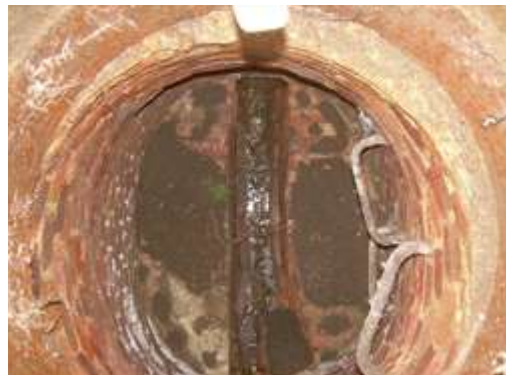
Top View

Bench and Channel debris.

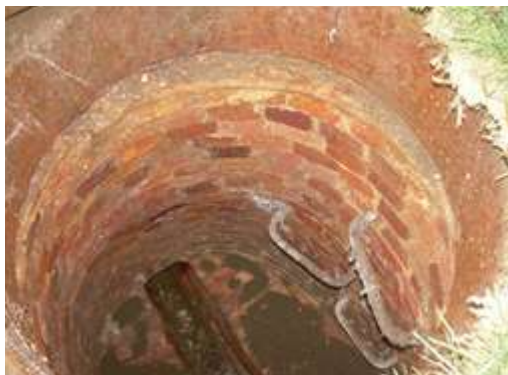
Defect

Adjustment deterioration and infiltration.
Barrel infiltration - other side.

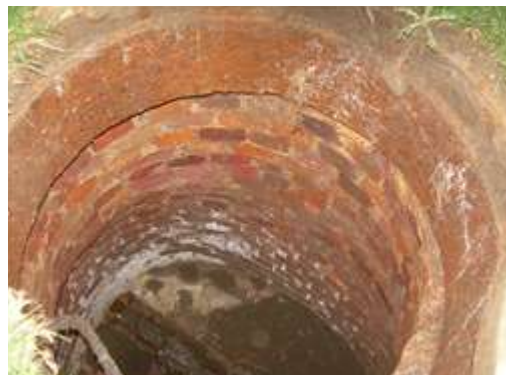
Defect

Adjustment deterioration and infiltration.
Barrel infiltration.

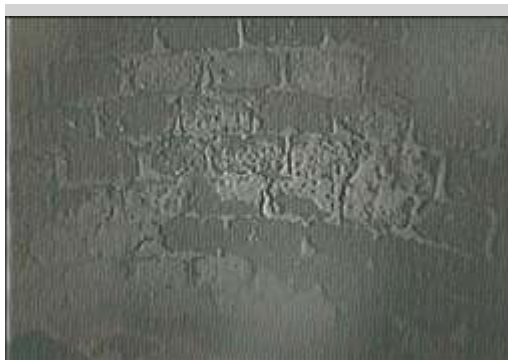
Defect

Barrel deterioration and infiltration.

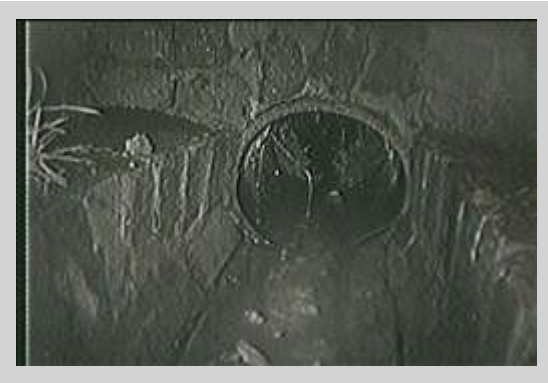
8 in. Circular Gravity Sewer Pipe Out @ 12 O'Clock

Channel deterioration.

Deposits: ☐ None ☒ **Mud** ☐ Sludge ☒ **Debris** ☐ Grease

Silt Depth: **0** (in.) Deposits Extent: **Light**

Infiltration: **Evidence** Pipe Seal Cond: **Cracked**

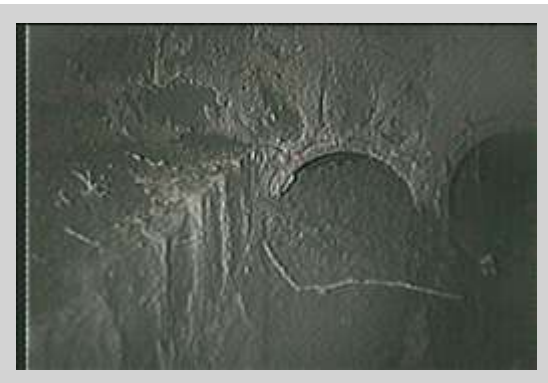
6 in. Circular Gravity Sewer Pipe In @ 5 O'Clock

Deposits: ☐ None ☒ **Mud** ☒ **Sludge** ☒ **Debris** ☐ Grease

Silt Depth: **5** (in.) Deposits Extent: **Heavy**

Infiltration: **Evidence** Pipe Seal Cond: **Cracked**
